MEMORANDUM FOR Record

SUBJECT: Codiga Farms Baseline Monitoring Report

CODIGA FARMS HABITAT RESTORATION

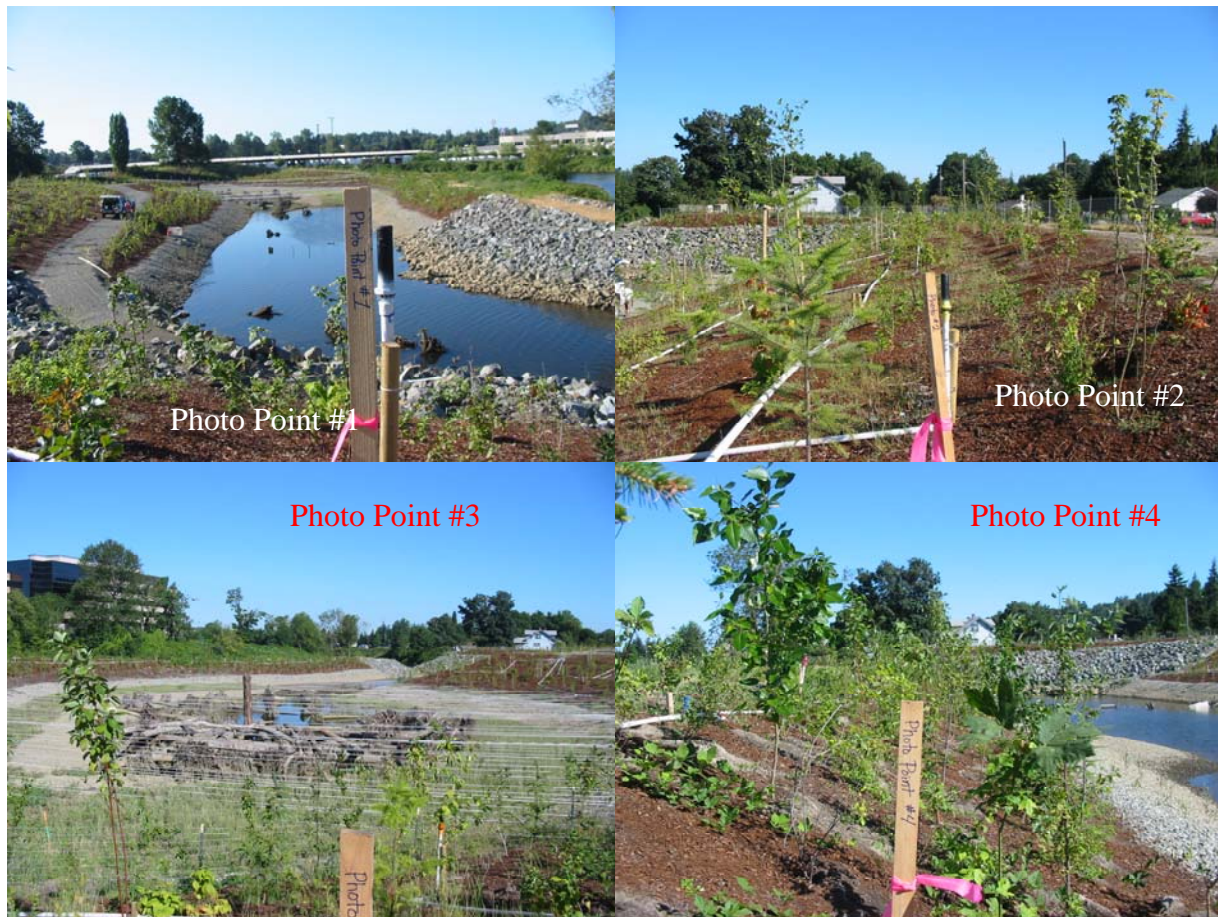
Figure 1. Photo point pictures established 22 July 2004 at the Codiga Farms Side Channel Restoration Project, Tukwila, Washington.

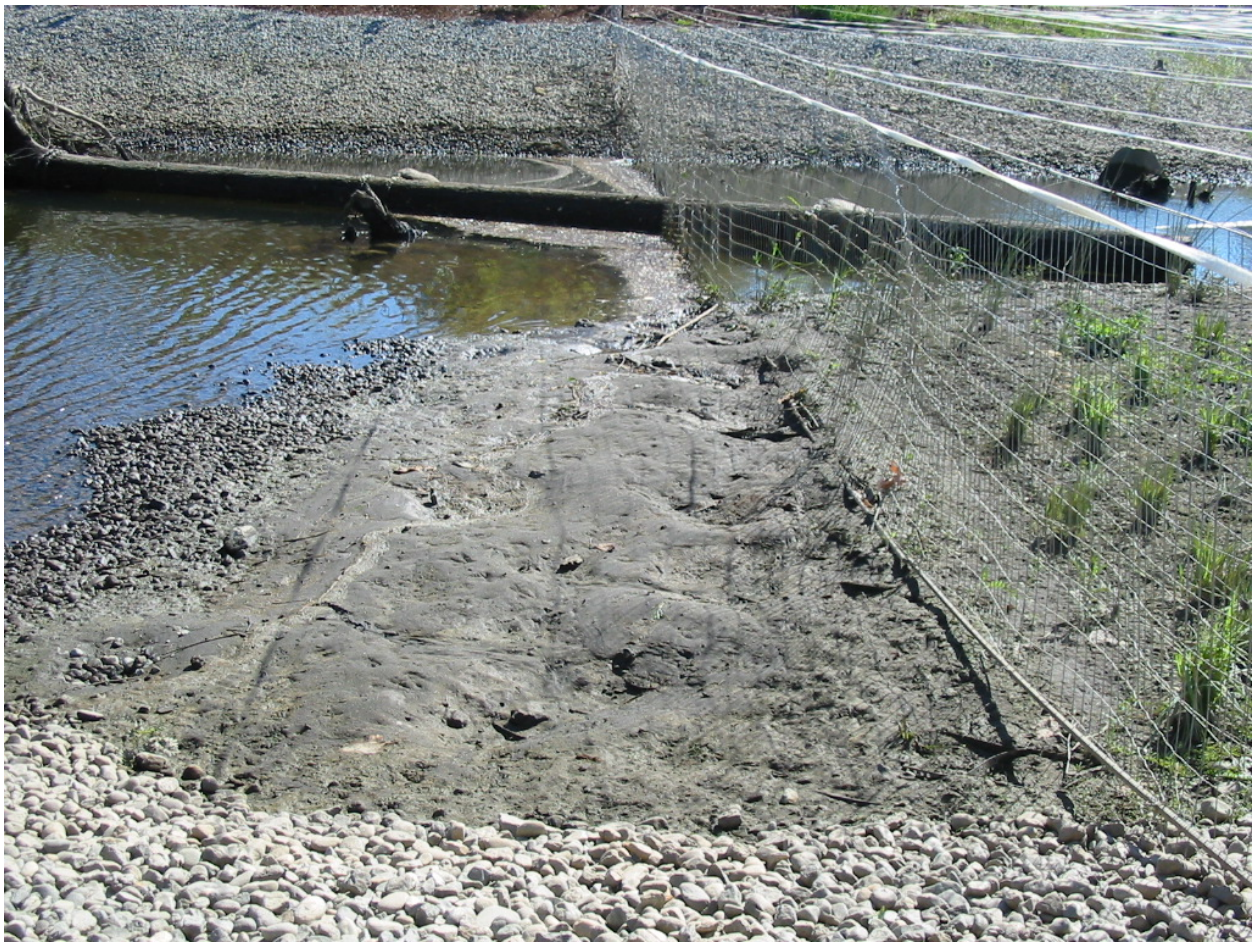
3. **Goose Excluder Function:** The goose excluder, as constructed, is functioning very well. As the attached photo, below, shows, plants placed outside the goose excluder have been consumed, while plants within the excluder are robust and thriving. There is extensive “evidence” of use of the project site by Canada geese, and we believe they would be consuming the marsh plants without the proper protection. Of particular interest is the success of the nylon/plastic-webbed tape used for the top of the structure. This tape, Pacstrap P40RW Polyester Cord Strapping, has proven to mimic “Scare Tape”. We recommend it be used in future restoration projects for goose exclusion (Specifications are attached at the end of this document).

Figure 3. Edge of goose excluder, showing difference in condition of areas planted within and outside the excluder; from the Codiga Farms Side Channel Restoration Project, Tukwila Washington.
